PDO – TDS SHEARED BOLT HEAD

Report ID: PDO – TDS sheared bolt head

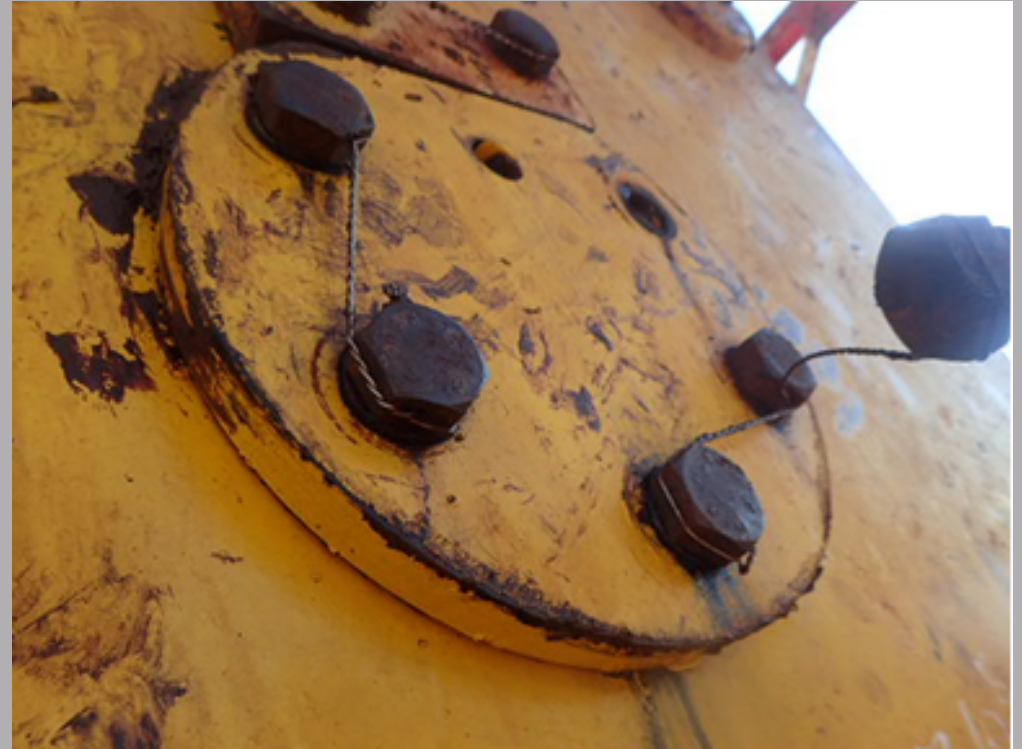
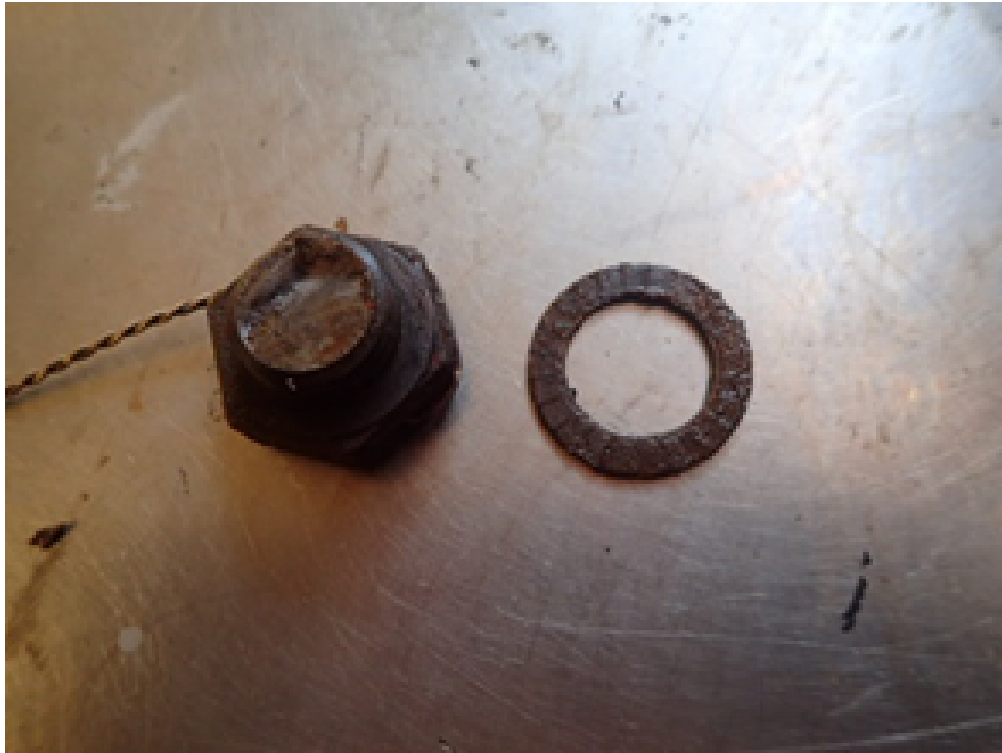
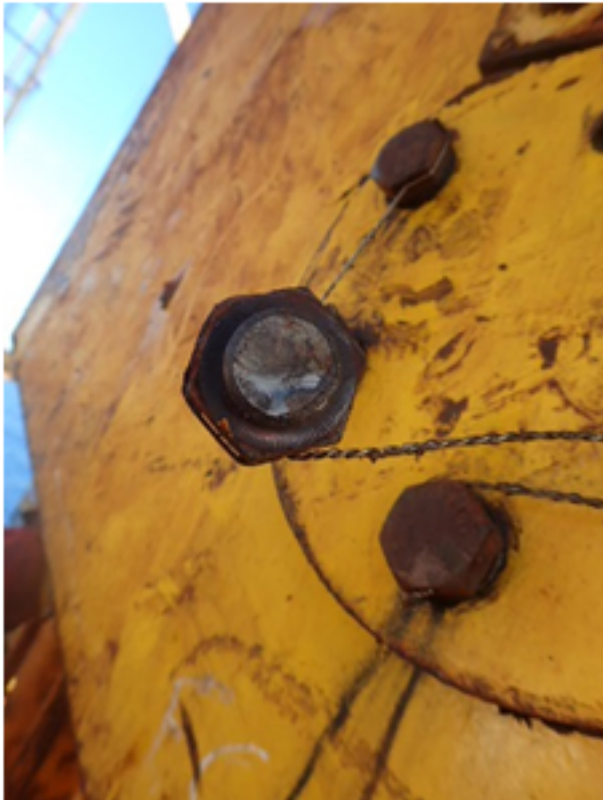
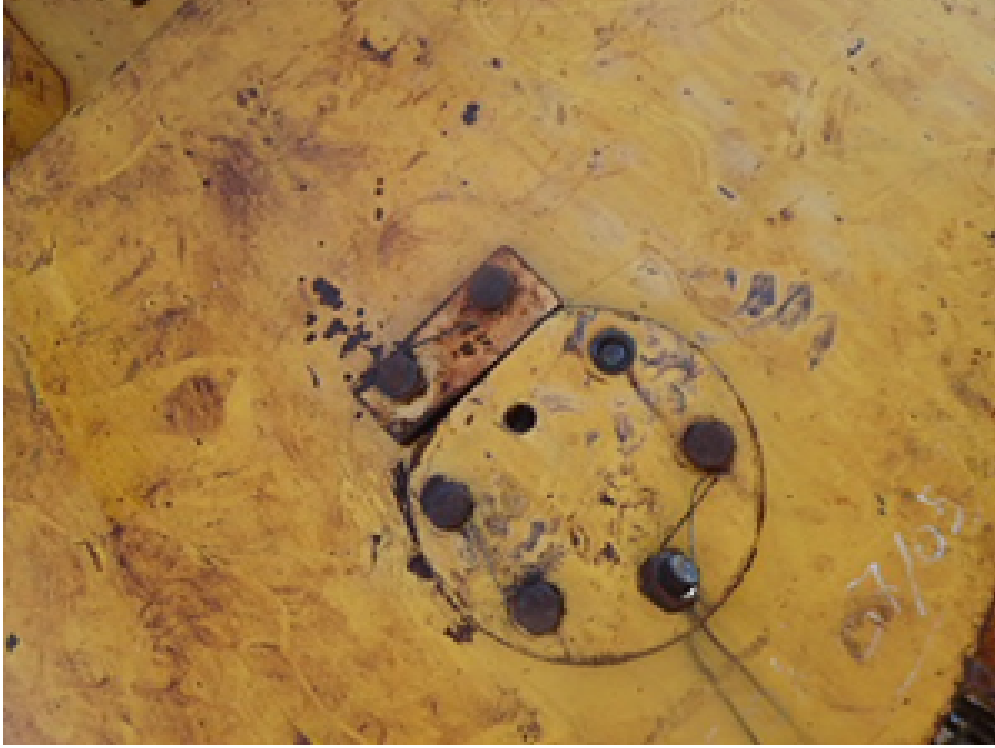
During TDS greasing a bolt with a sheared head was found on the travelling block becket pin. The bolt head was hanging by the lock wire. The sheared was removed and replaced by Motorman

- Fatigue from movement and vibration during operations.
- Wear and tear

- Keep focused on perform regular PDO hunt
- Maintain daily TDS DROPS inspection during Drilling operations
