DROPS - SHEARED BOLT DROPPED ON RED ZONE

Report ID: DROPS - Sheared bolt dropped on the red zone while drilling (1119866)

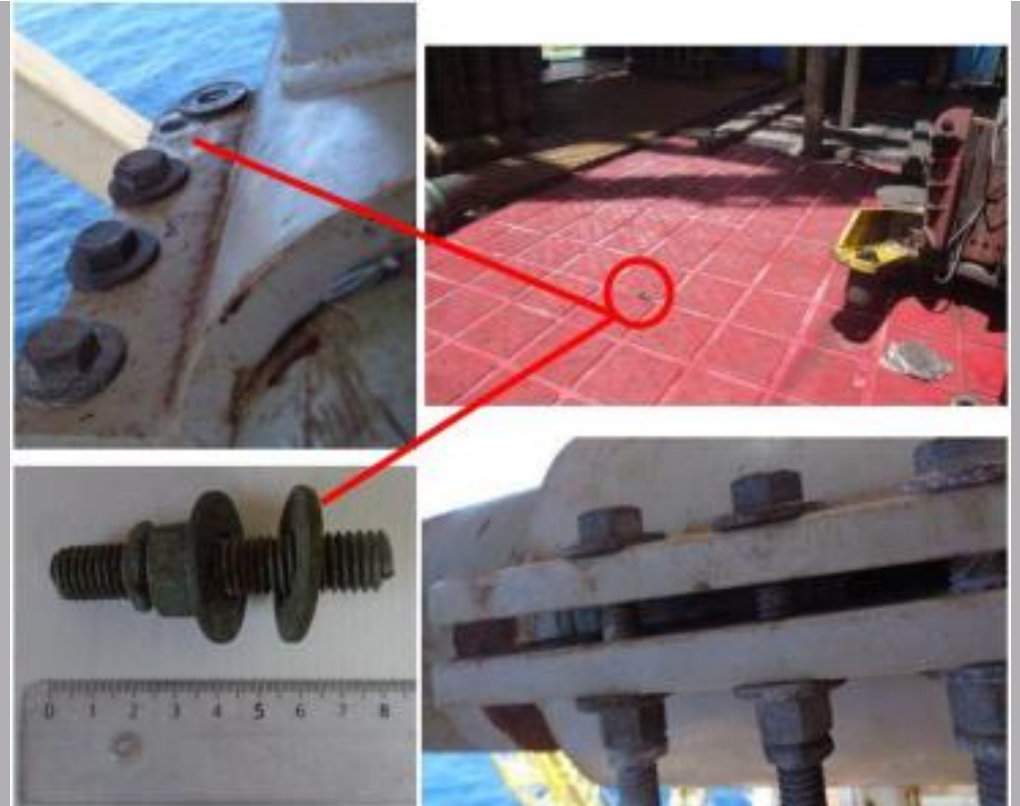
While in the doghouse with the Driller discussing operations, Toolpusher and driller heard a bang on the doghouse roof. When investigating a bolt was found lying on the red mats at the V door. It was noticed that the bolt had come from the newly installed clamp on the gooseneck under the monkey board and could be seen from the Doghouse on the camera in the derrick. A floor man and Maintenance team went up to check if the clamp was still secure checked all other bolts, and replaced bolt.

Height: 24m, Weight = .08g

Resulting in the impact been 17.4 joules

- Used wrong type of equipment/tools – Equipment not suitable to withstand vibrations.
- The product was not satisfactorily tested/inspected/certified – Believed that material was not within specification for this application.

- Always check that the technical specification of the equipment is suitable for the intended use
