PDO - PART OF SCAFFOLDING POLE FOUND ON WALKWAY

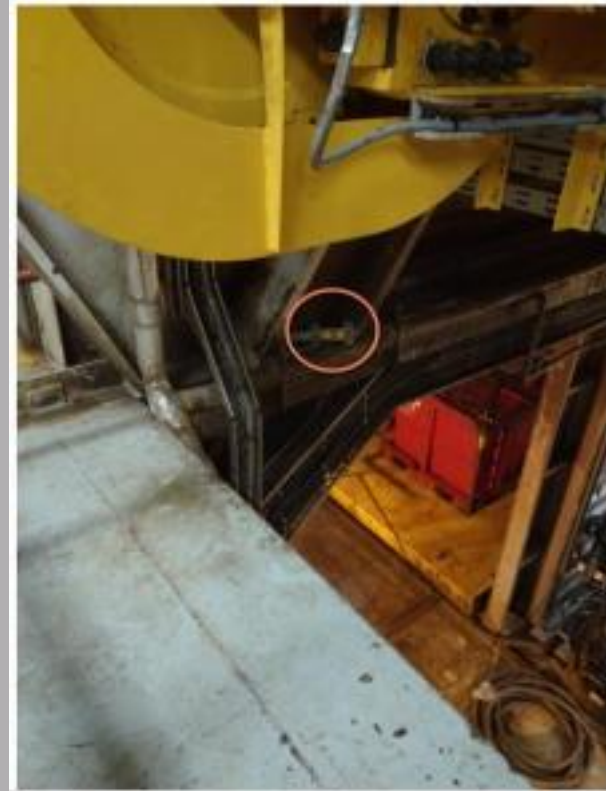
During a PDO check a part of a scaffolding pole was found lying on a walkway above the BOP deck in the structure on derrick, west side . The object was removed immediately.

Weight of the object: 1.1 kg, approx. 30 cm long.

Potential drop height: 5 m.

Drop area was not barred off.

DROPS calculator: 54 J – Minor

Left item: A scaffolding was taken down a couple of days before the observation and removal of the object. The object has most likely been forgotten when the area was cleared.

Inform the 3rd party contractor about the finding and the importance of removing all loose objects after completing work
