DROPPED OBJECT ON RIG FLOOR

Report ID: 269776

Installations: EkoX

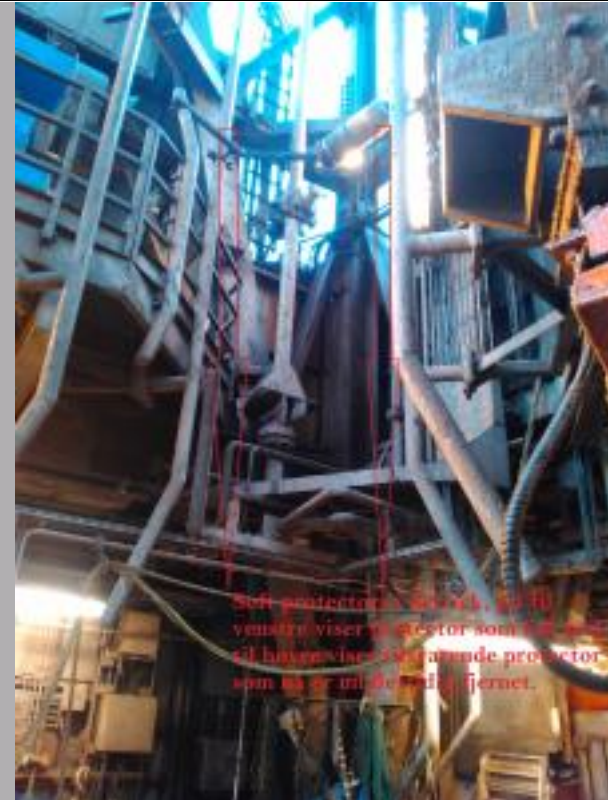
A soft protector on rig floor beam fell down and landed inside red zone. No personnel inside red zone.

Weight of protector 2.2 kg. height 5.5 m x 9.81 = 119 Joule. The protector is made of soft material. The protector is placed on the beam to protect hoses for TD when moving TD up and down. The protector was installed next to the protector on the picture.

Protector was not included in the DROPS checklist, so the potential for it falling down was not identified.

Update DROPS checklists to include this and similar equipment mounted in derrick.

The protector on the picture is taken down as a precautionary measure.
